Energy Efficient Ventilated Façades for Optimal Adaptability and Heat Exchange enabling low energy architectural concepts for the refurbishment of existing buildings.

E2VENT WORKSHOP

DEMO IN SPAIN AND POLAND

Diego Romera
ACCIONA

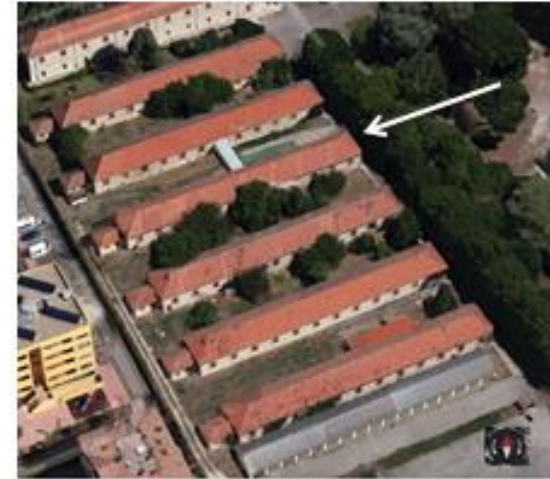
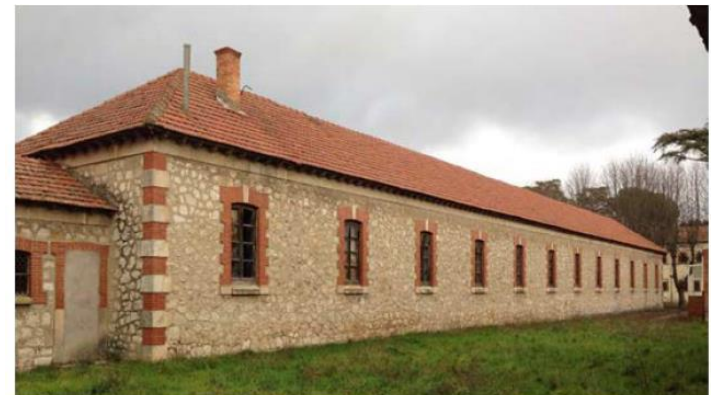
- University building in Burgos
- One-level block, with pitched roof, masonry walls of 65cm thickness , not-insulated
- Centralized heating system. No mechanical ventilation
- Related Pathologies:
 - Comfort:
 - Low Indoor Environmental Quality
 - Energy-Related Pathologies:
 - Poor Building Envelope
 - Low Performance of heating system

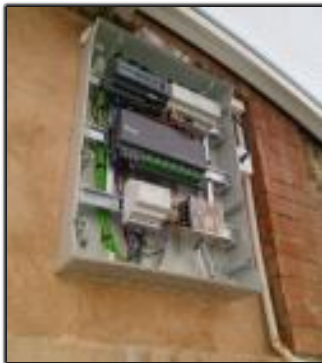
- Two rooms of study: Lecture Room, PC Room
- Monitoring System
 - Energy Consumption
 - Internal comfort conditions
 - External weather conditions

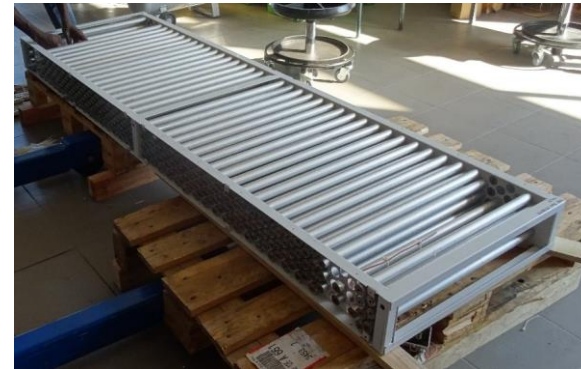
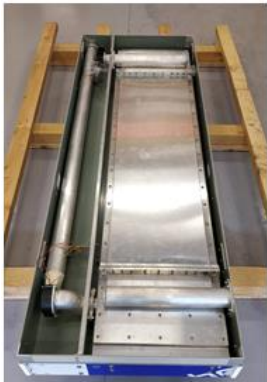
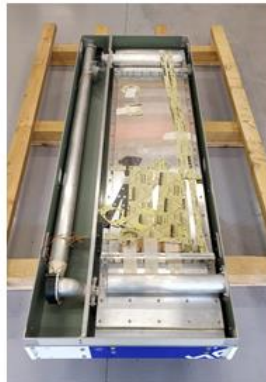
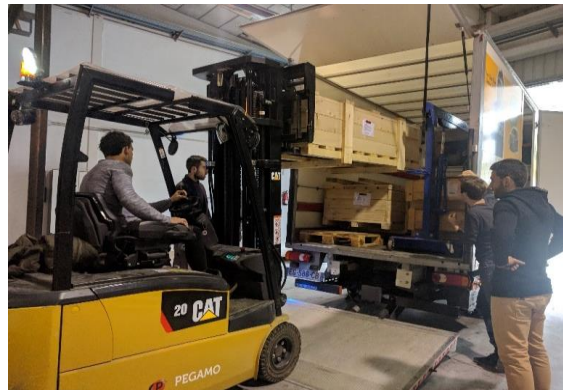
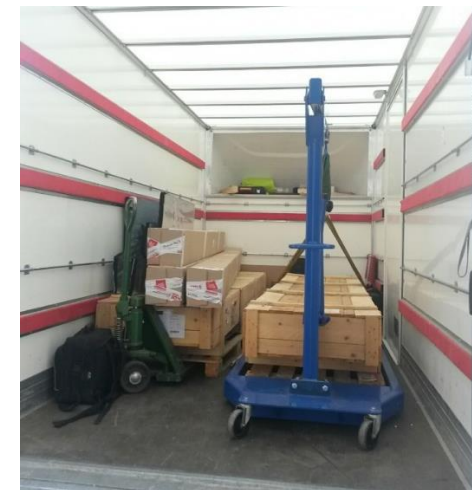
- Manufacturing
- Pre-assembling in factory
- Transport to the site

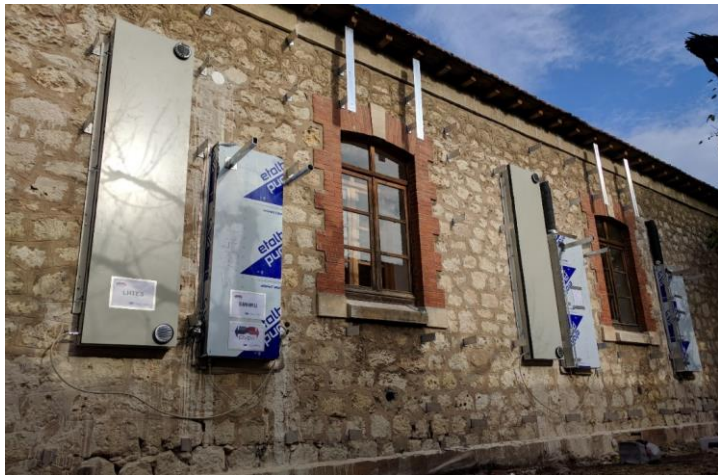
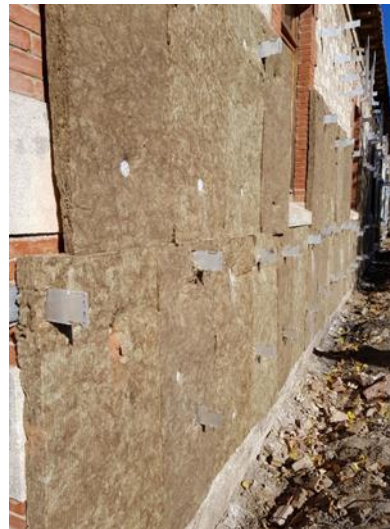
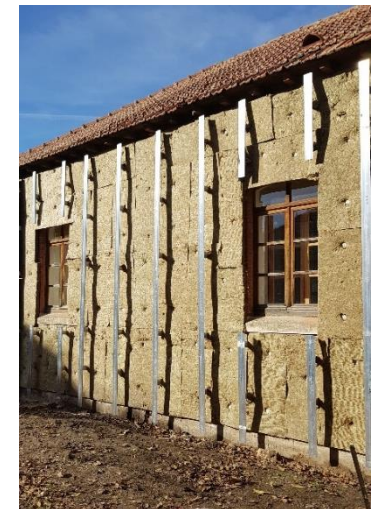
- Envelope: Ventilated façade modules, windows, insulation.
- Prototypes (LHTES, SMHRU)

- Dampers and fans
- Airtightness
- Air flow
- Acoustic

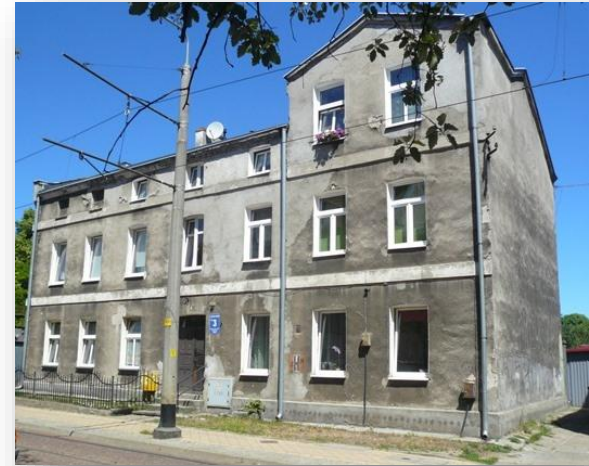
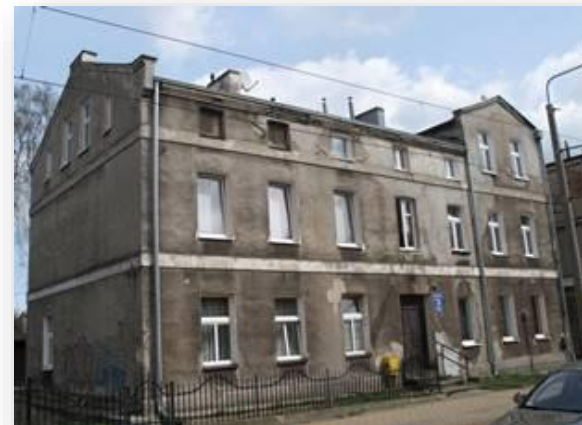
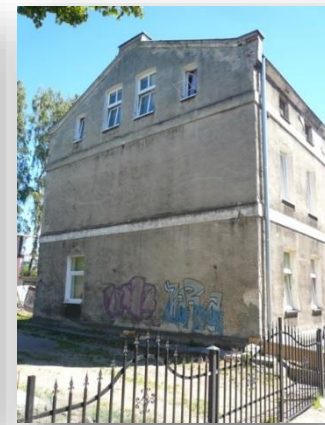
- Multi-family residential building in Nowy Port, Gdańsk
- External walls from full brick with thickness 38 cm, not-insulated
- 10 flats
- Individual heating system. No mechanical ventilation
- Related Pathologies:
 - Comfort:
 - Low Indoor Environmental Quality
 - Energy-Related Pathologies:
 - Poor Building Envelope
 - Low Performance of heating system

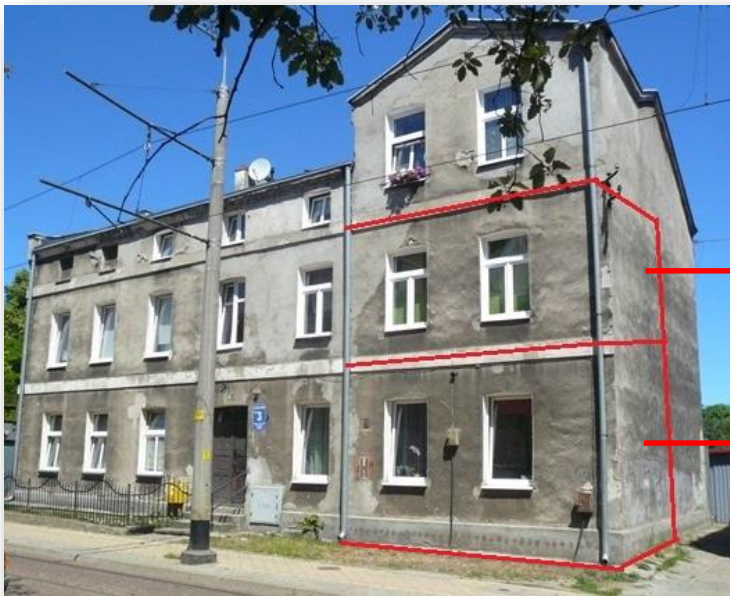
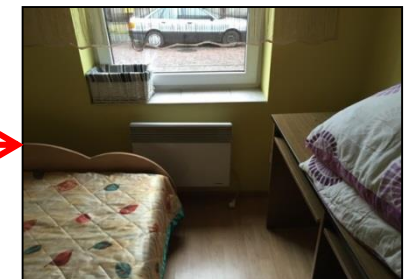
- Two dwellings of study: ground floor, first floor
- Monitoring System
 - Energy Consumption
 - Internal comfort conditions
 - External weather conditions

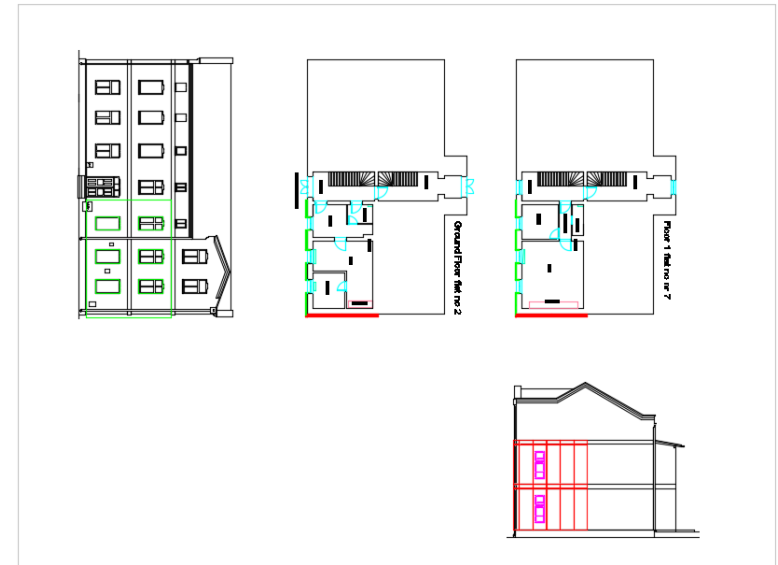
- Envelope Upgrade
 - Ventilated façade (South orientation)
 - ETICS (West orientation)
- HVAC upgrade
 - Ventilation System with heat recovery (SMHRU)
 - Control System (BEMS)

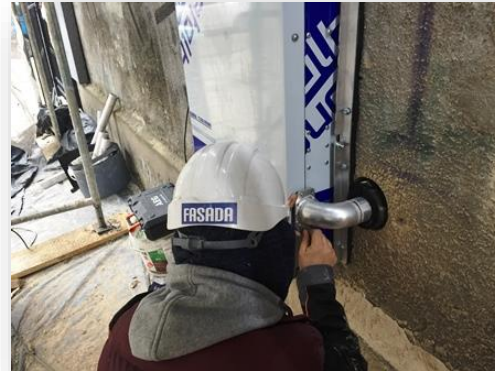
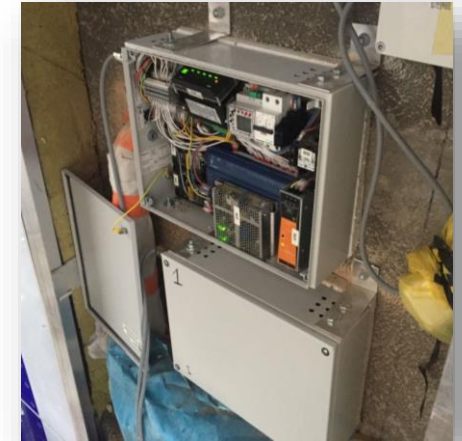
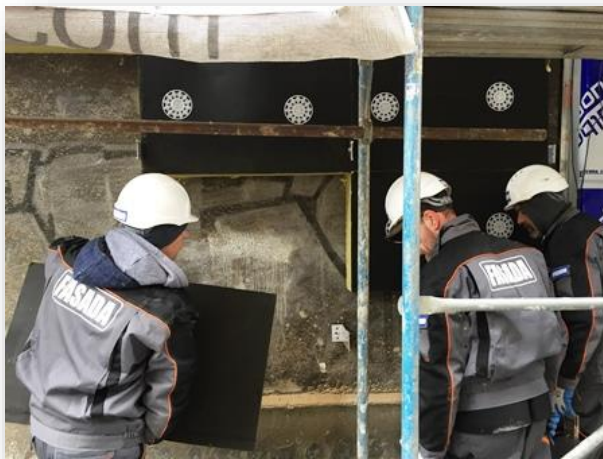
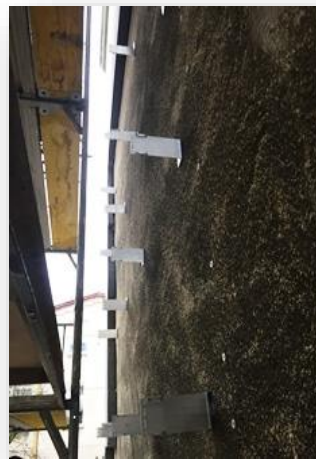
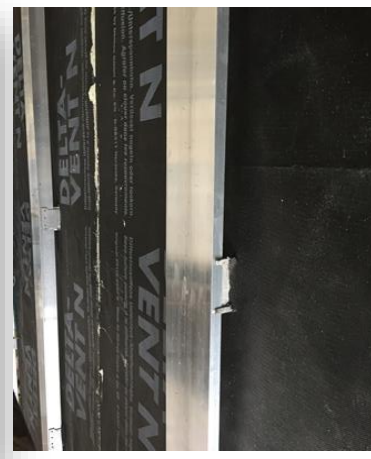
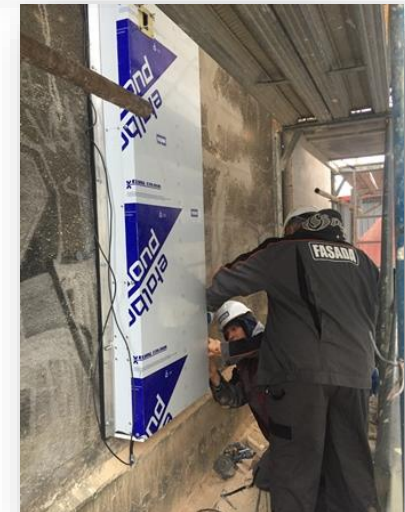
- Manufacturing
- Pre-assembling in factory
- Transport to the site
- Installation

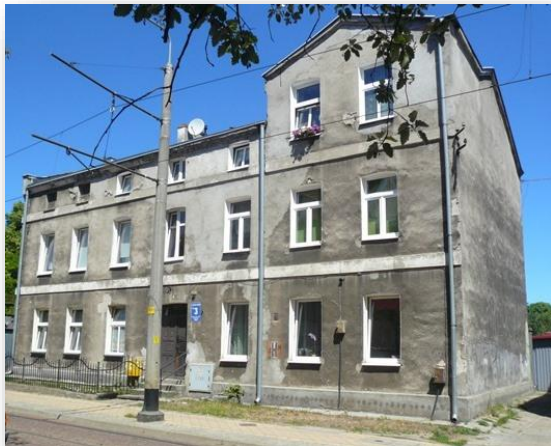
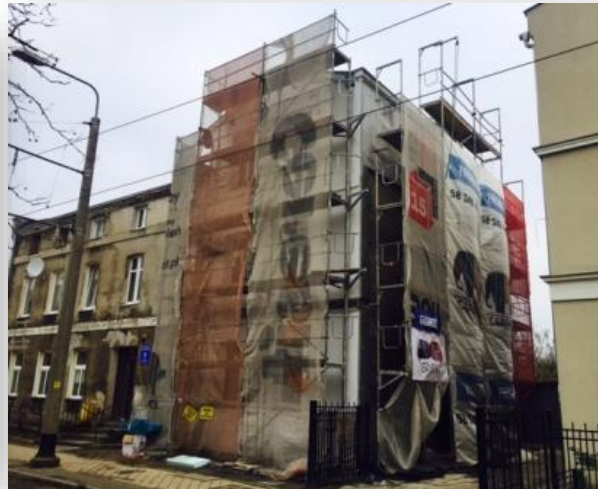
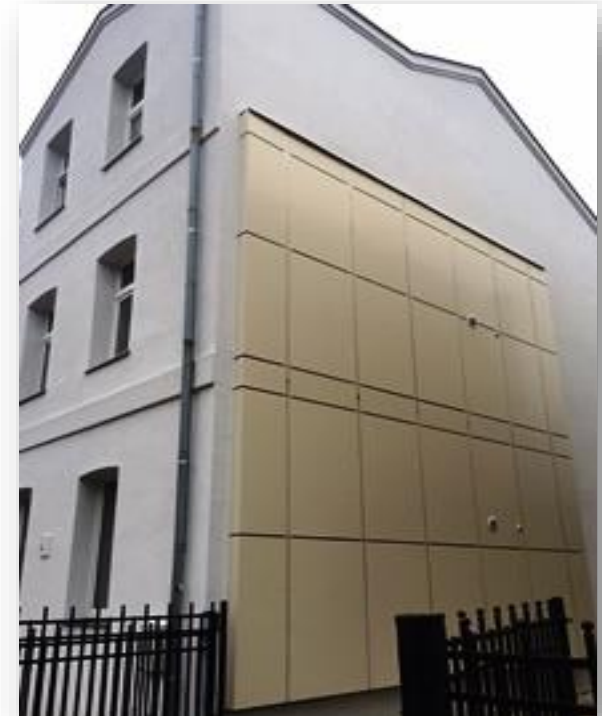
- fans
- Airtightness
- Air flow
- Acoustic

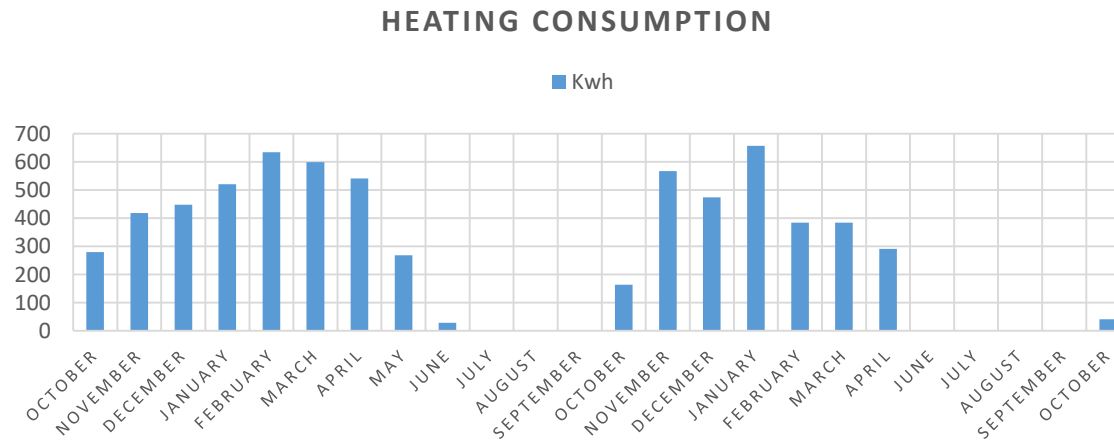
- Pre-Monitoring data
